U. S. ARMY ENGINEER DISTRICT, LOS ANGELES
CORPS OF ENGINEERS
LOS ANGELES, CALIFORNIA

**PRADO DAM
EMERGENCY PLAN
INUNDATION MAP**

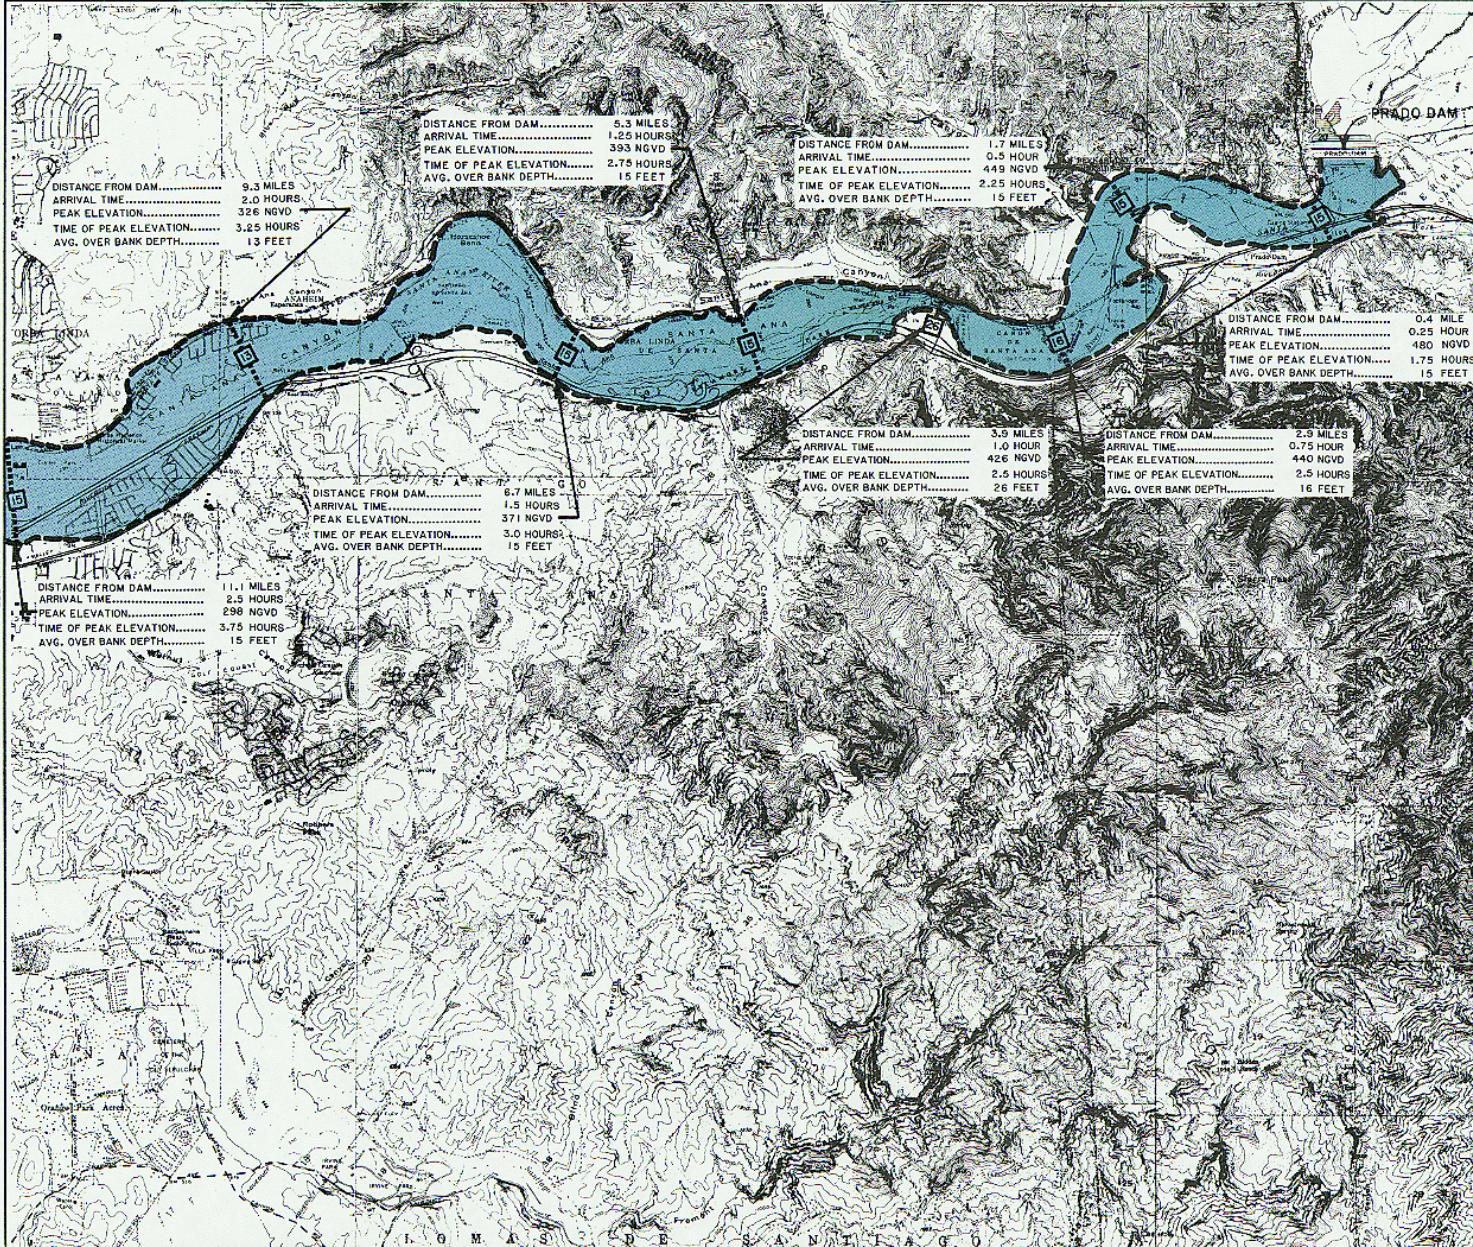
N 5-03

Limit of flood due to dam failure with the pool at spillway crest, elevation 543 feet.

Average overbank depth in feet at cross section.

NOTE: The inundated areas shown on this map reflect events of an extremely remote nature. These results are not in any way intended to reflect upon the integrity of the Prado Dam
